STAR ONLINE PUBLICATION

Case Number: S2219000005

Symptom/Vehicle Issue: Dielectric Grease In Electric Power Steering (EPS) Connectors.

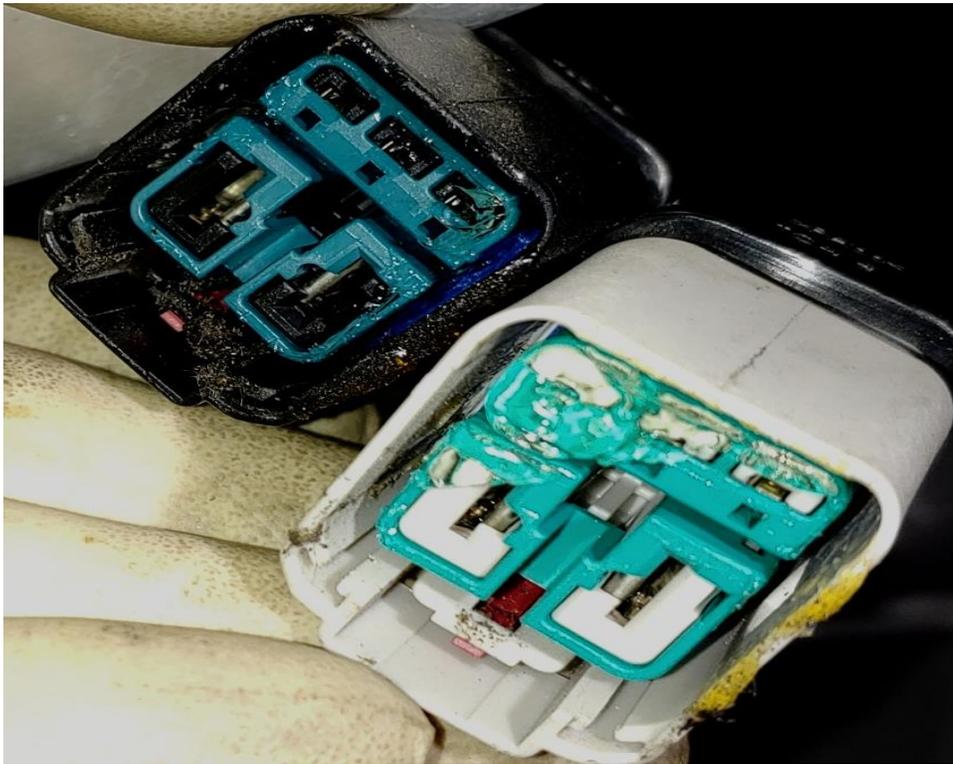
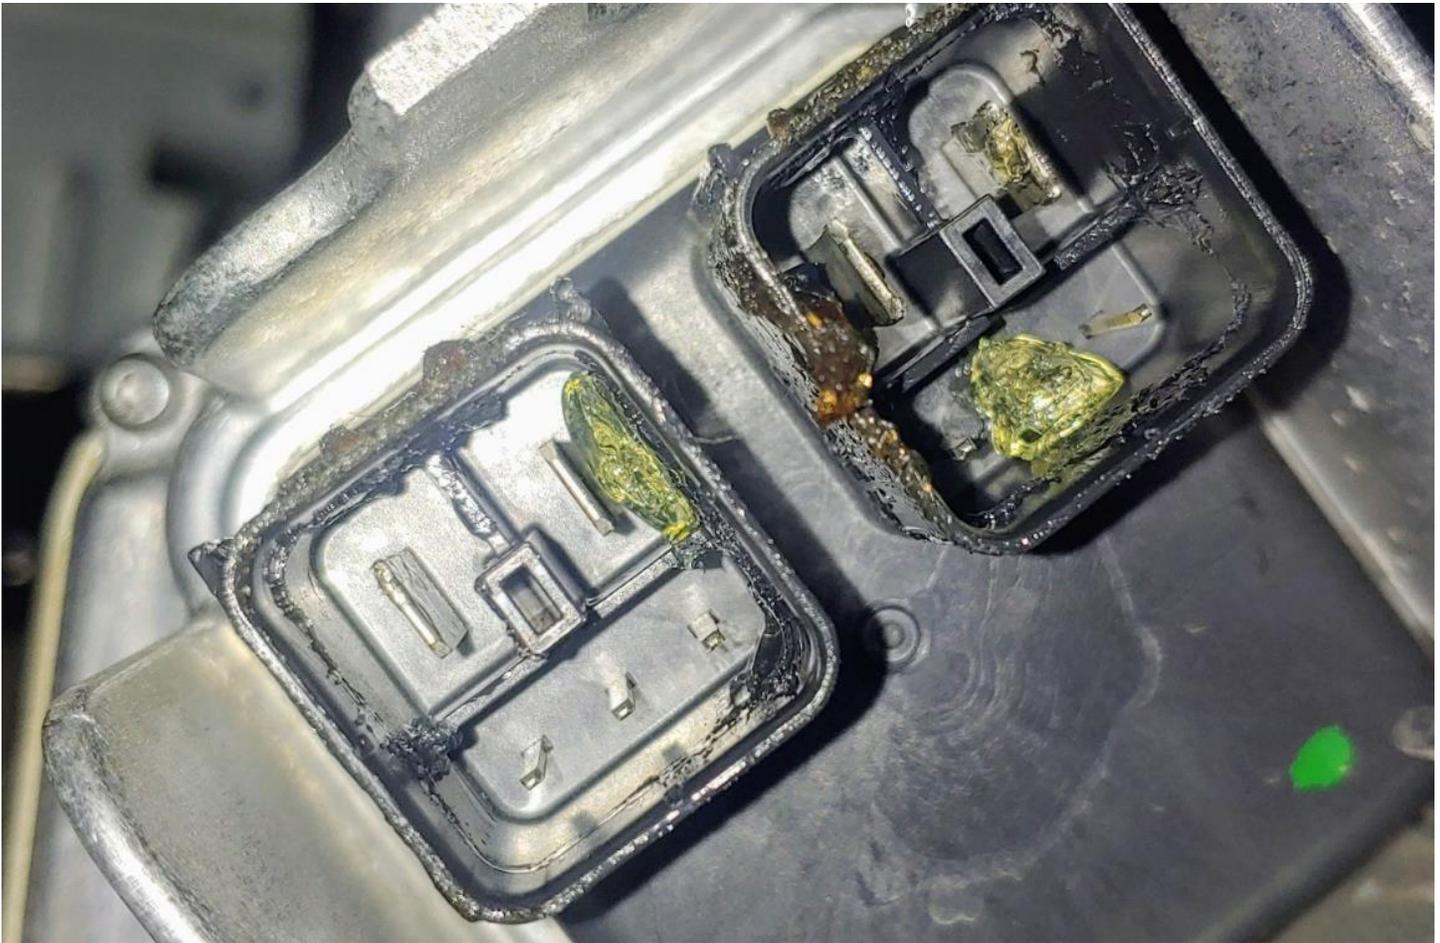
Discussion: Comments from field technicians show concerns with the amount of grease found in the EPS connectors. The amount shown in the images is applied at assembly and is correct. Dielectric grease is used in this location due the EPS location and contact with moisture. Do not remove the factory applied grease.
